TECHNICAL APPRAISAL AND QUOTE

TECHNICAL APPRAISAL of the KING GEORGE V PLAYING FIELD, ARDRISHAIG

Project: Upgrading of the natural grass pitch area

Date of assessment: 16th of August, 2024

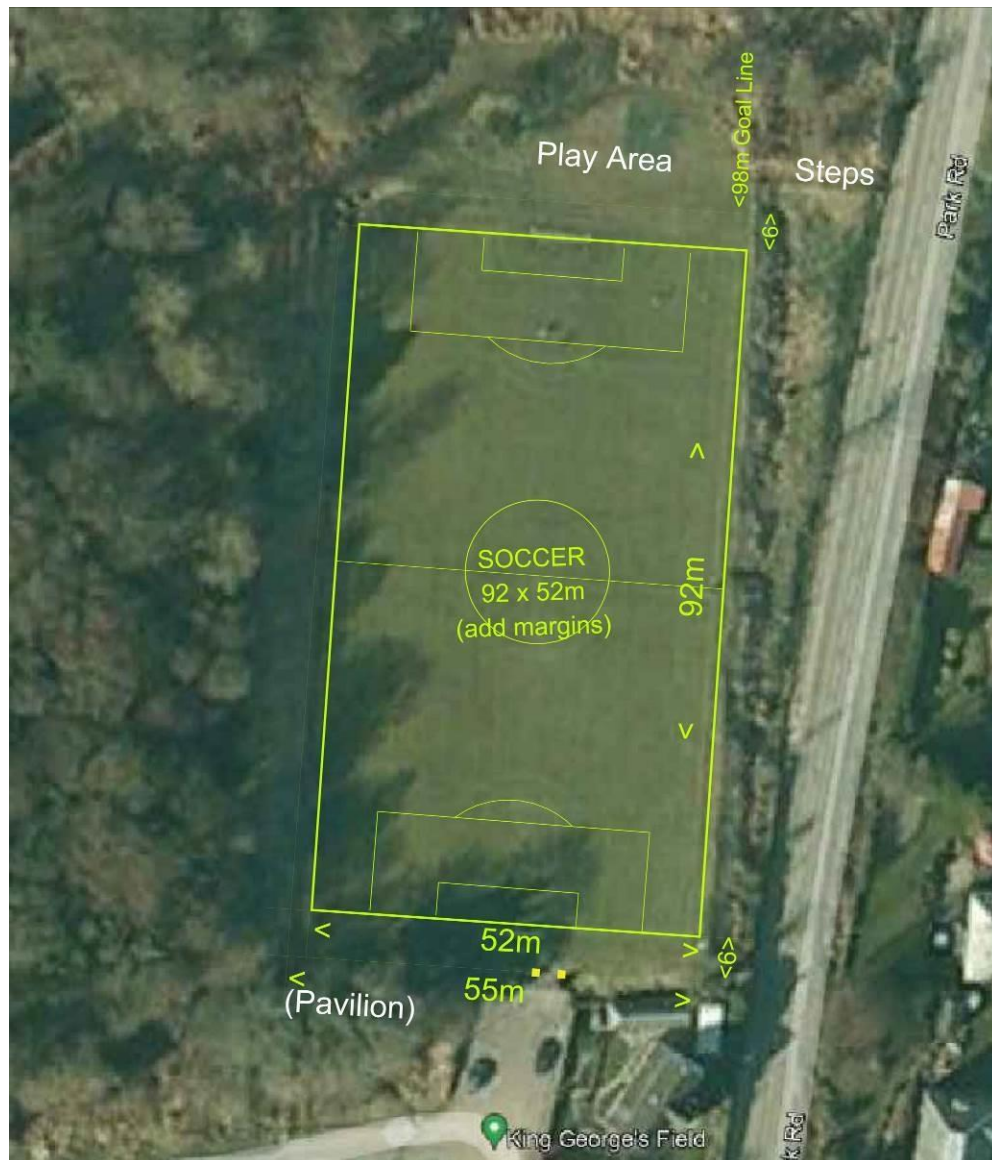
Fig. 3 - The extent of the playing area available was measured on the ground as 92 x 52m including margins (minimum 2m) with an additional 2-3m available to the western side if scrub is removed, plus other adjustments

- 1) The existing playing field has a playing surface effectively of 92 x 48m plus 2m margins to the sides and 6m approximately to each end.
- 2) The length of the pitch is limited by a large drain chamber and access ramp in the north-west corner and play area fittings. The width is limited by the embankments on either side and the cut-off drain along the bottom of the western bank, this being overgrown on the day of the visit.
- 3) The southern end of the pitch is close to the access point and residence, 6 metres from the current goal-line to the access gate. Scope exists to make the playing area slightly larger and potentially to move the pitch further in towards the north, giving a greater margin for errant balls and making room for parking, potentially.

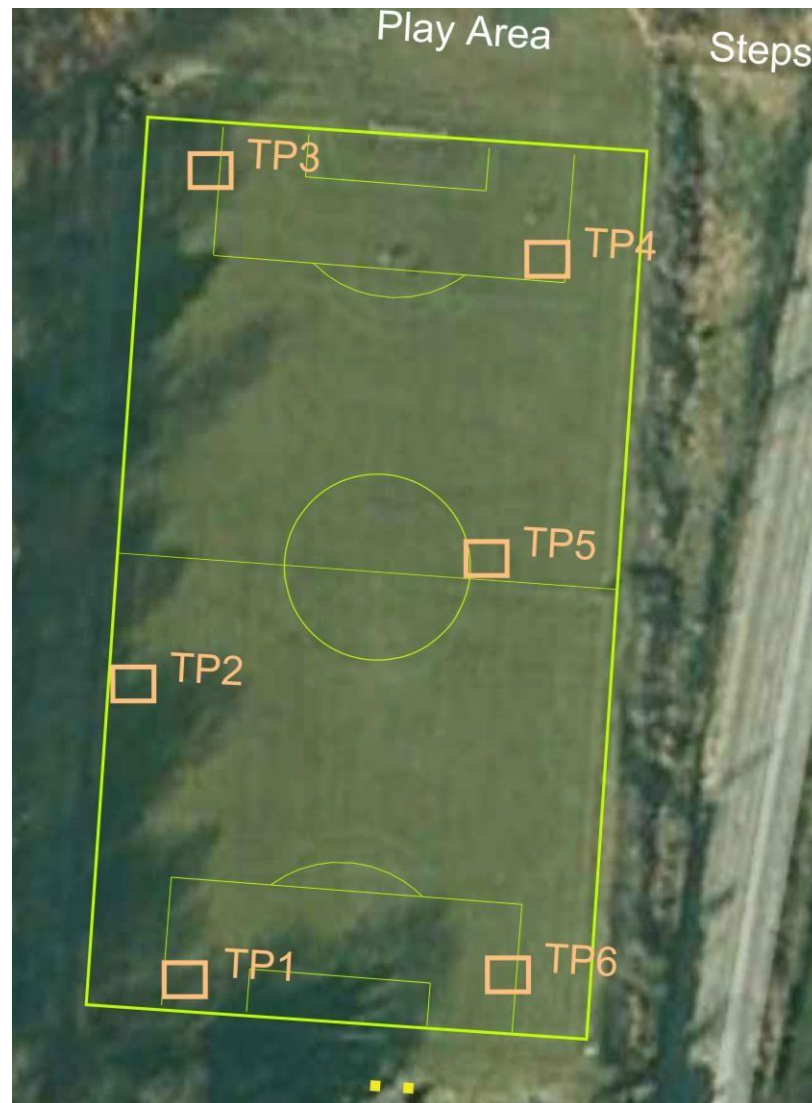
Fig. 5 – Soil trial pit locations

- 1) Soil pits were excavated to assess the topsoil and upper subsoil conditions. Six pits were dug by hand with a spade, supplemented by a Dutch Auger where possible to examine deeper into the subsoil. These pits were supplemented by checks using a depth gauge probe and notches taken with the spade to check soil depth and compaction elsewhere around the site.
- 2) Topsoil depth was found to be approximately 120 - 170mm of mid-brown clay loam with the upper 80 to 100mm being compacted. All pits were wet, with waterlogging on the western side. Below the topsoil layer was a stoney subsoil to the east, weathered mica schist rock to the west. It appears that levelling the pitch by cutting on the west to raise it on the eastern side was significantly inhibited by the presence of the bedrock.

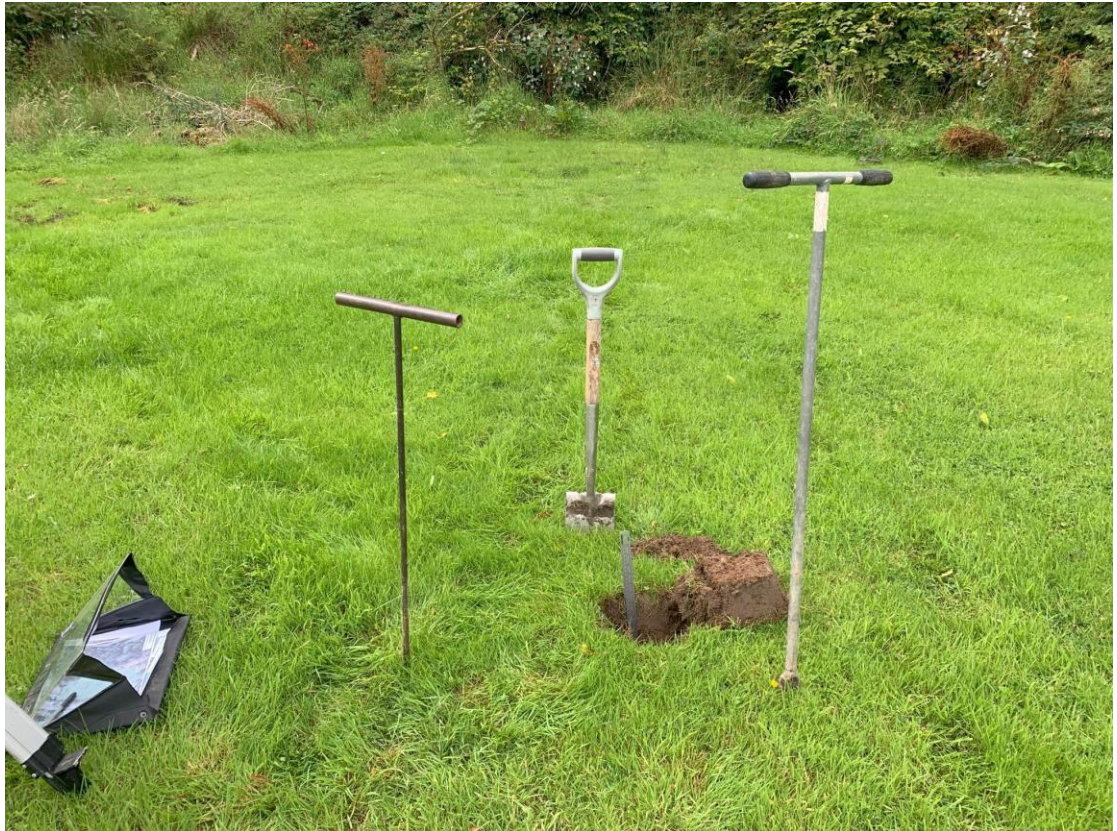
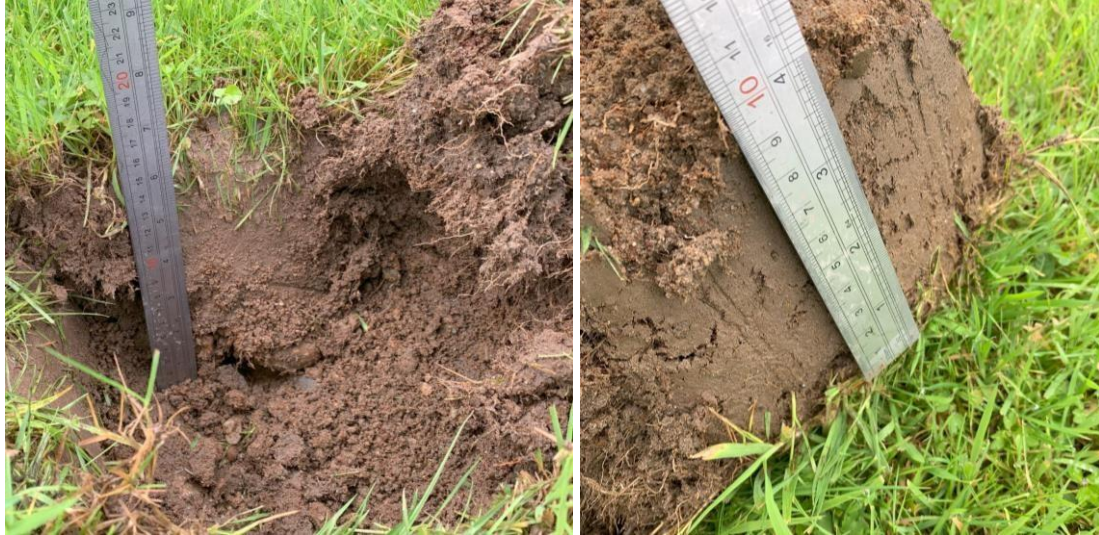
- **Trial Pit 1** – South-western corner of the playing field. Topsoil 160mm deep, top 100mm mildly compacted with limited root depth below this. Hard, brown stoney subsoil, augering not possible due to the presence of rock

***Trial Pit 1 – 160mm of loamy topsoil over a drain run with fine gravel permeable fill.
Compact 100mm upper layer with limited root depth, hard subsoil.***

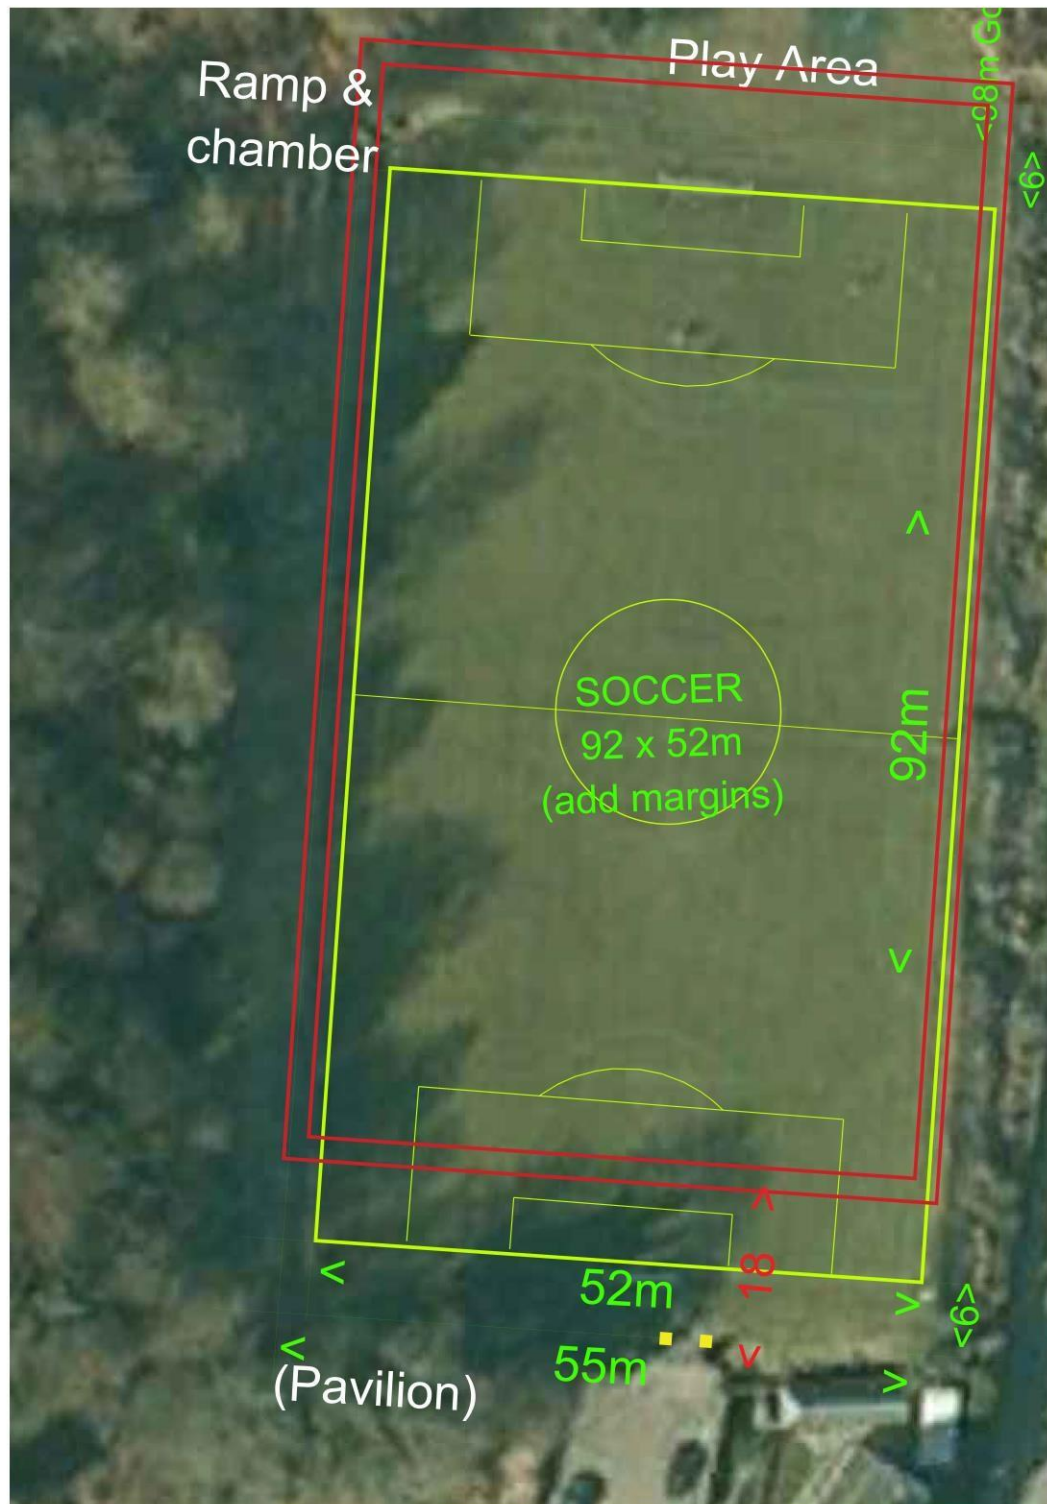
Fig. 10 –pitch relocation option in red, 18 metres between pitch margin and boundary, widened area for playing surface plus 2m margins, requires work to the chamber and ramp to the north east.

Moving the pitch even further north might allow the play accessibility from Glengilp Road end

- 1) A concept sketch is shown in Fig. 10 above, where the pitch size could be retained or slightly increased in width but moved north to allow other developments.
- 2) The pitch resulting might just accommodate two U11 cross-pitches and margins, depending on the feasibility of excavating the western bank.
