Coll & Tiree Vet's Practice Feasibility Study

John Gilbert Architects, with NBM Construction Cost Consultants

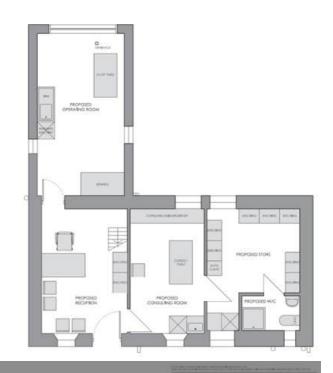
The plan of the existing practice, unheated large animal and laundry to the top, reception, consulting room and store from left to right along

Mark and Anne showed us around the existing facility and explained the ways in which it was possible to make work, but how it was far from adequate, and moreover in breach of the incoming RCVS guidelines. This was helpful in understanding the brief and veterinary practice more generally, as well as allowing for a useful comparison with the 'ideal' practice layout provided by Mark on the next page.

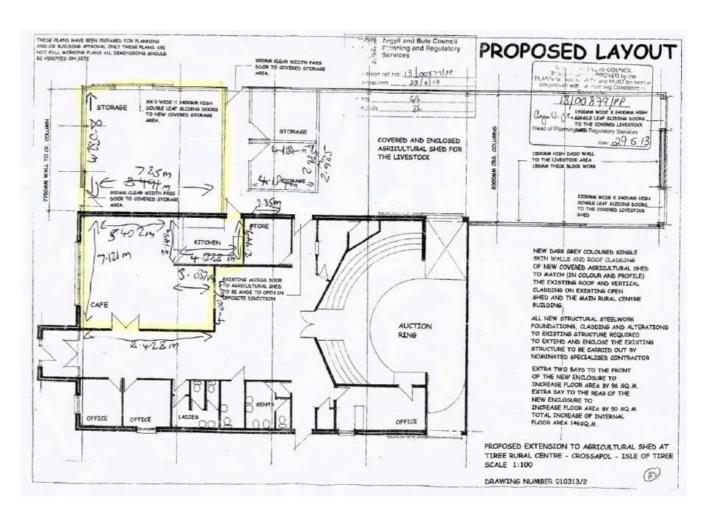
Floorplan of available space at Tiree Rural Centre, highlighted in yellow.

The space made available is shown on the drawing, right which shows the whole Rural Centre in plan, and the area for the veterinary practice outlined in yellow. The drawing shows the original Rural Centre building below in the darker black lines and with the auction space to the right, built in the 1990s. The longer rectangle running along the top of the drawing is a more recent agricultural shed extension from around 2013.

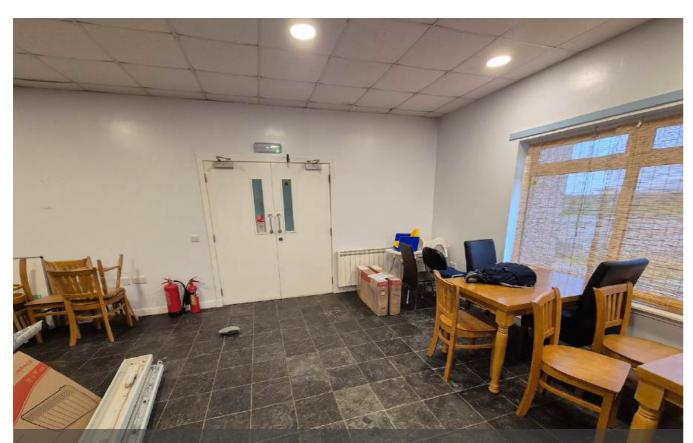
View of the existing double door entry into the Cafe which will be retained under the proposals.

The existing cafe space has a double door entrance from the main entrance corridor and a large window to the left as you enter which overlooks the entrance and car park area. There is an electric fire and radiators, as well as a good deal of lighting. A hatch and bar towards the back of the room connect to a fairly small kitchen area which retains several cooking facilities.

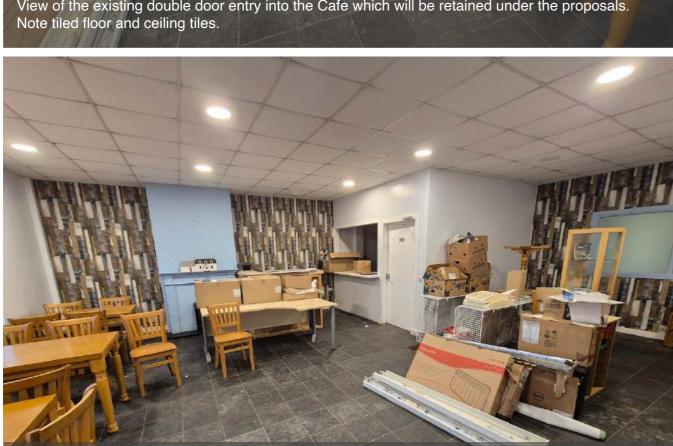
View from the entrance door looking towards the Kitchen and hatch / bar. Note internal window to the right and false chimney / electric fire in blue on the wall facing. Furniture would need to be removed.

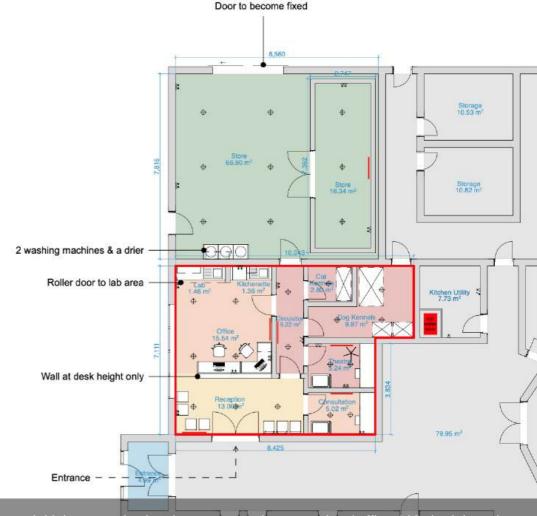
Option 1 of the two initial proposals showing an open plan reception / office with the lab and kitchenette placed along the rear of the office space.

Initially, we completed two options, the difference between them being the means of entering the practice. In option 1, we assumed that all users would enter through the existing main door and porch, and then turn left to enter the practice through the existing double doors. This was the simplest and cheapest option but had two potential problems: security and cleaning / maintenance. Option 2 imagined that it may not be acceptable to use the same entrance, and we indicated a new and separate entrance to the left of the existing porch, with a new porch and new entrance door into the reception area through the end of what is now the wide window. This would have been considerably more costly and in the feedback received in January 2025, it was confirmed that this was not required.

In the first options we placed the laboratory space which is required by the recent RCVS guidelines in the office, alongside a kitchenette, separated by a wall between and in the case of the laboratory space, by a roller door to keep the space hygienic. In the current version, the lab has been moved into the consulting room, but still with flexible separating screen, while the kitchenette remains part of the office space.

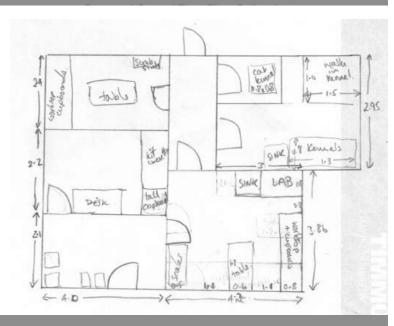
The sketch provided by Anne to indicate the preferred layout, having reviewed the plans shown above. This sketch was then translated into the current layout shown in Section 8.
